Re: Preliminary findings pertaining to forensic engineering investigation of damage and distress to 15 story condominium building; Insured: Mustang Towers; Claim No.: 1027766; Policy No.: 65884208; Property Address: 6109 Highway 361 in Port Aransas, Texas; Date of Loss: 8/25/2017; Our File No.: 18-207

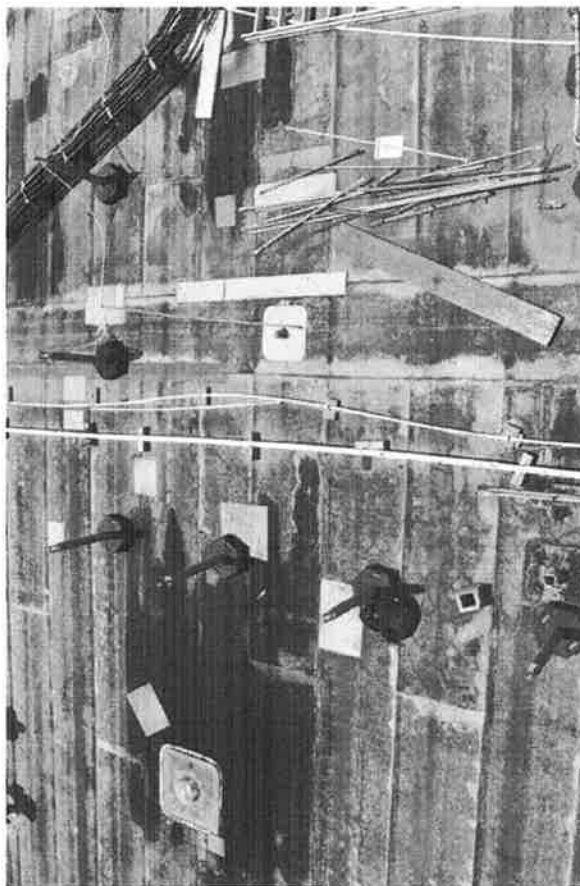
2. The mod-bit built-up roof on this condominium building was in an aged and deteriorated condition. It was readily apparent that this mod-bit roof covering had long ago reached the end of its useful service life. As a result of the severe age related deterioration in this mod-bit roof it should have long-ago been replaced as part of the long-term maintenance of the building.

Photograph 8: View of aged and deteriorated mod-bit roofing (typical)

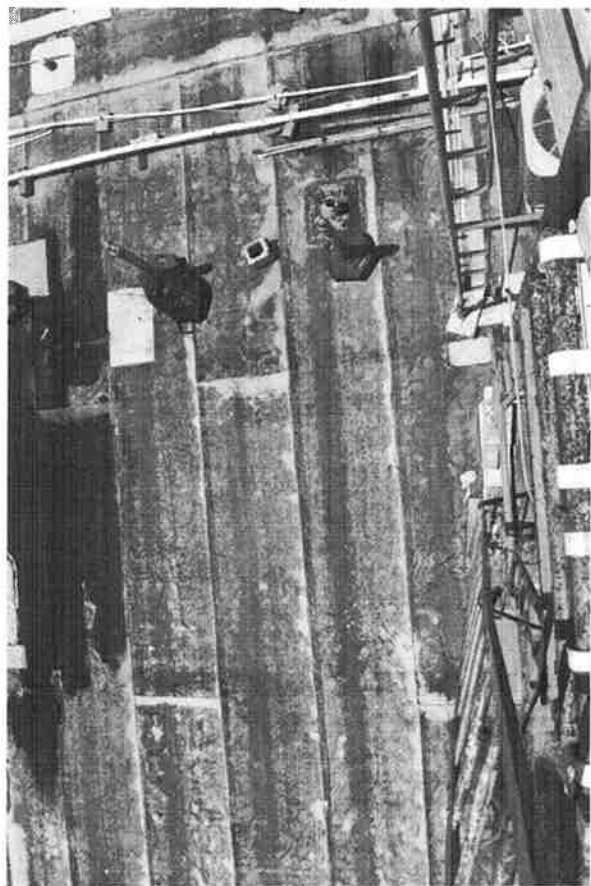
Photograph 9: View of aged and deteriorated mod-bit roofing (typical)

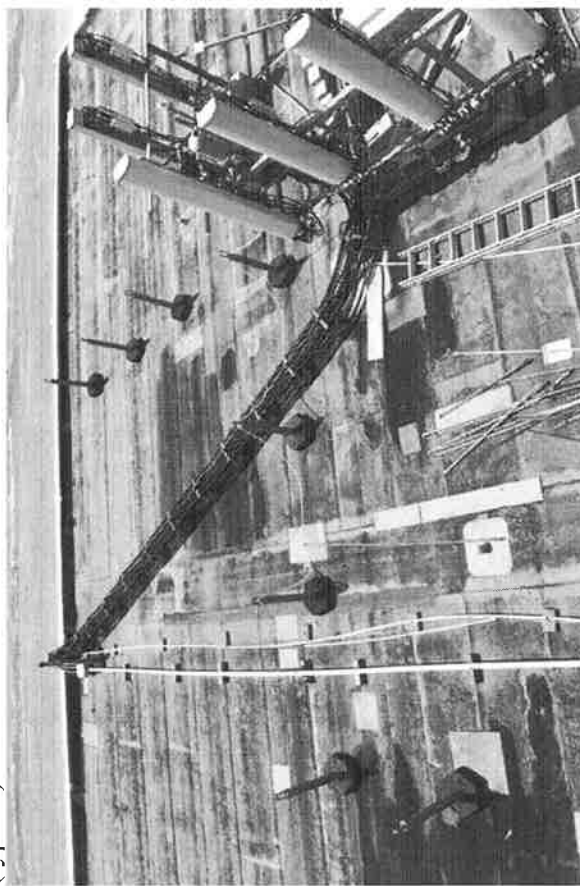
Photograph 10: View of aged and deteriorated mod-bit roofing (typical)

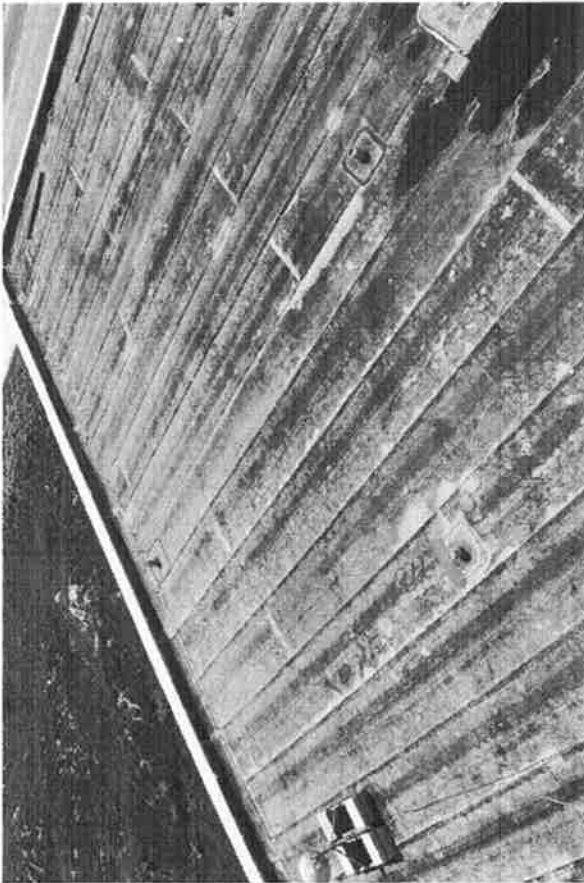
Photograph 11: View of aged and deteriorated mod-bit roofing (typical)

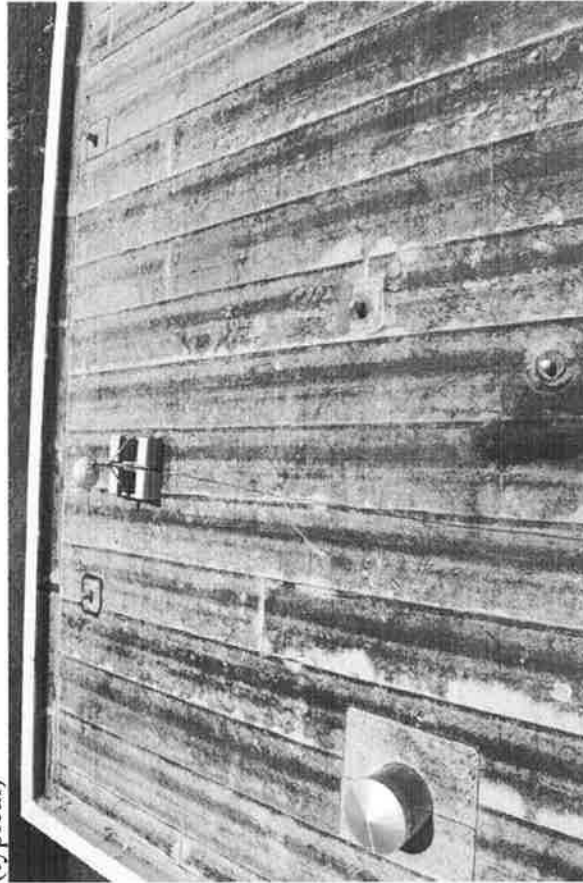
Photograph 12: View of aged and deteriorated mod-bit roofing (typical)

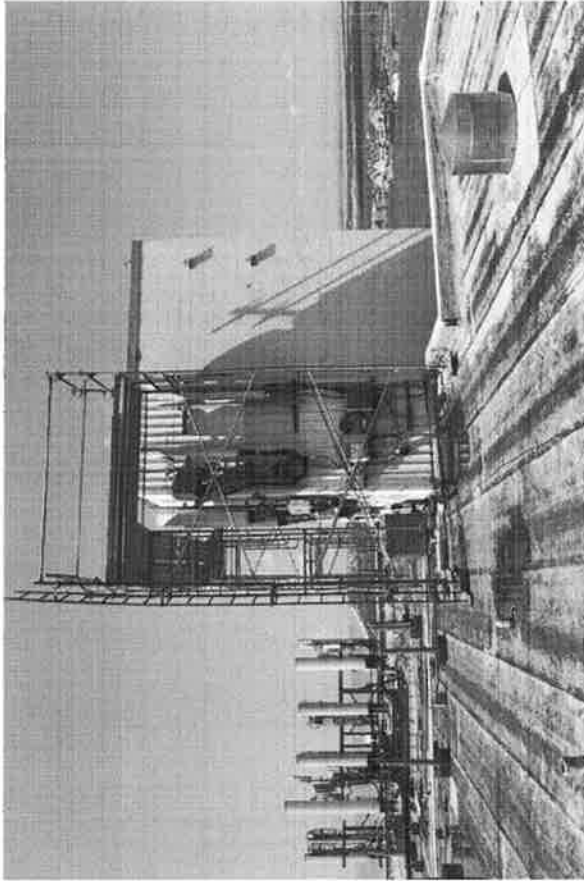
Photograph 13: View of aged and deteriorated mod-bit roofing (typical)

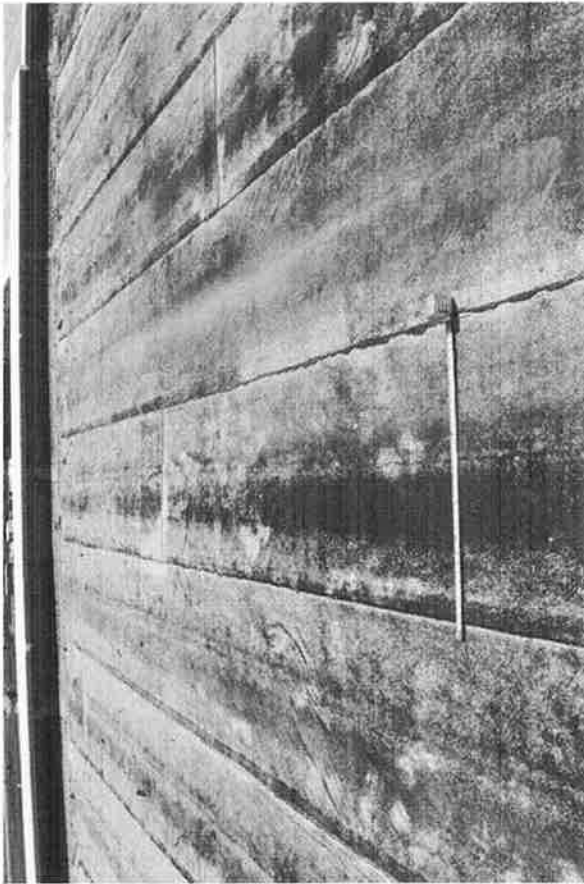
Photograph 15: View of existing repairs to aged mod-bit roofing (typical)

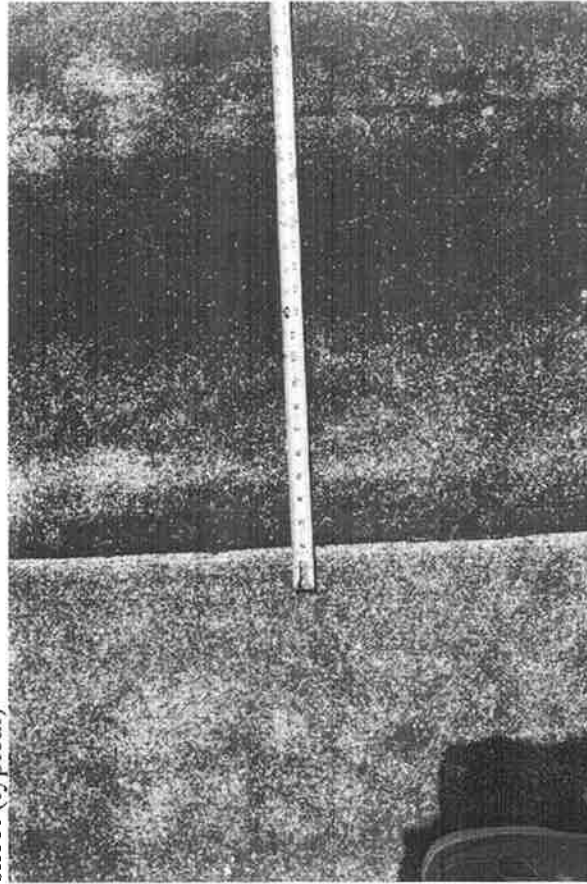
Photograph 16: Severe granule loss on surface of aged mod-bit cap sheet (typical)

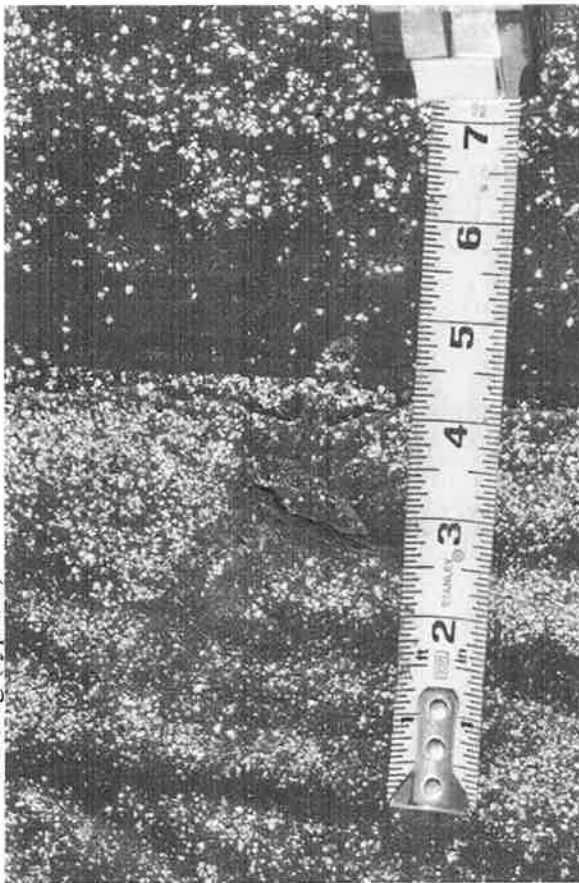
Inspection of the mod-bit roof on this building revealed one isolated gouge that could have resulted from wind blown debris (ref. photographs 22-23). According to information provided at the inspection the mod-bit roof on the building exhibited only minor damage immediately after the passing of Hurricane Harvey. As such, it was reported that an allowance was made for the repair of "*one square*" of the mod-bit roof, due to damage sustained by flying debris (ref. photographs 8-11 and 32-35).

Photograph 22: Isolated gouge in surface of aged and deteriorated mod-bit roofing (typical)

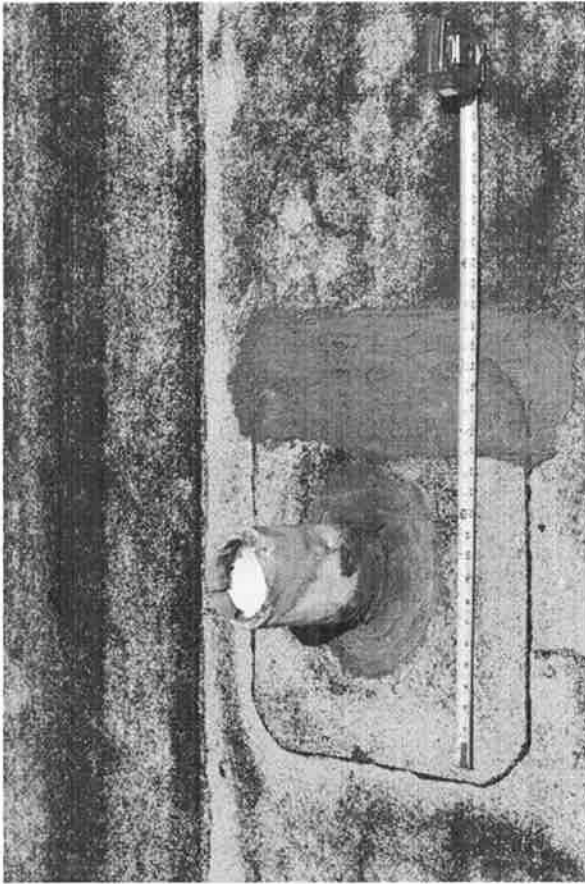
Photograph 23: Close up view of isolated gouge in surface of aged and deteriorated mod-bit roofing (typical)

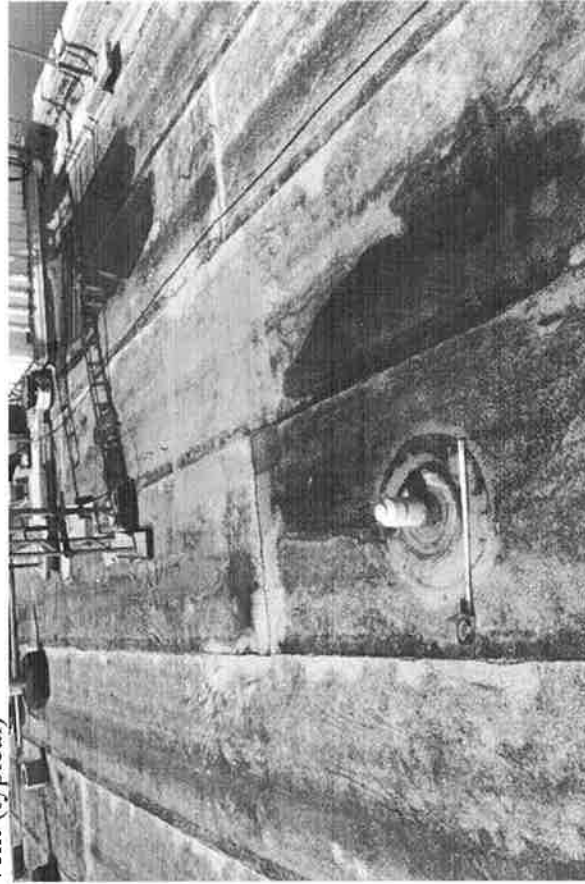
3. The mod-bit built-up roof revealed clear evidence of a long history of prior repair. These prior repairs include sealant applications along seams in the mod-bit cap sheet and base flashing and at flashing around plumbing vents.

Photograph 24: Existing sealant repair around flashing for plumbing vent (typical)

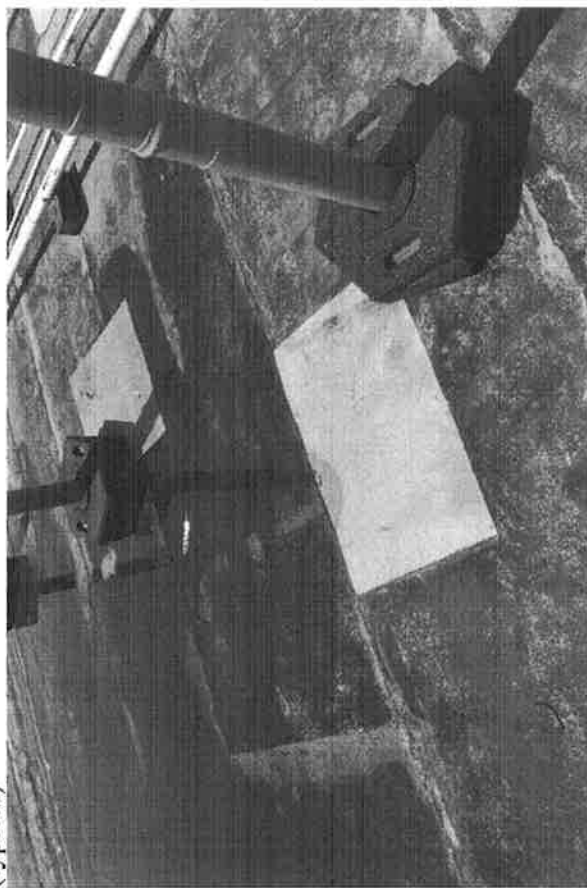
The modified bitumen (mod-bit) roof covering on this building was in a severely aged and deteriorated condition. The mod-bit roof was also poorly drained. There was ponding water located in several areas on the roof (ref. photographs 11, 25, and 32-33). This mod-bit roof had long ago reached the end of its useful service life and should have been replaced as part of the long-term maintenance of this condominium building. The cap sheet on this built-up roof had lost a significant portion of its granule surface (ref. photographs 16-23). Some areas of the mod-bit cap sheet had lost 90% of the protective granules (ref. photographs 20-21). Several seams in the mod-bit cap sheet exhibited evidence of prior repair (ref. photographs 24-25 and 28-29). Some adjoining seams of the base flashing had also been repaired with sealant on prior occasion (ref. photographs 26-27). Several of the repaired areas in the cap sheet are located in areas of ponding water (ref. photographs 32-33).

Photograph 32: Poorly drained area and repairs to mod-bit cap sheet (typical)

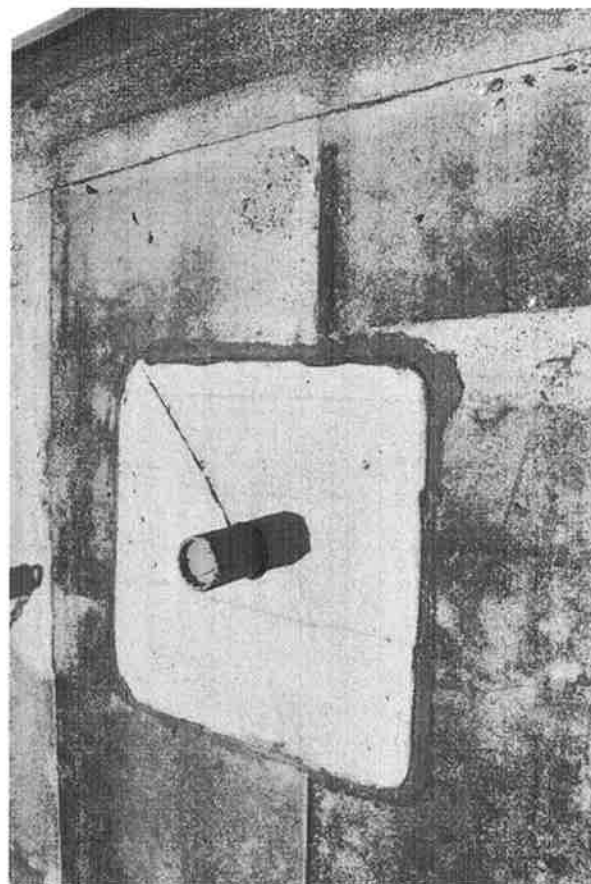
Photograph 33: Poorly drained area and repairs to mod-bit cap sheet (typical)

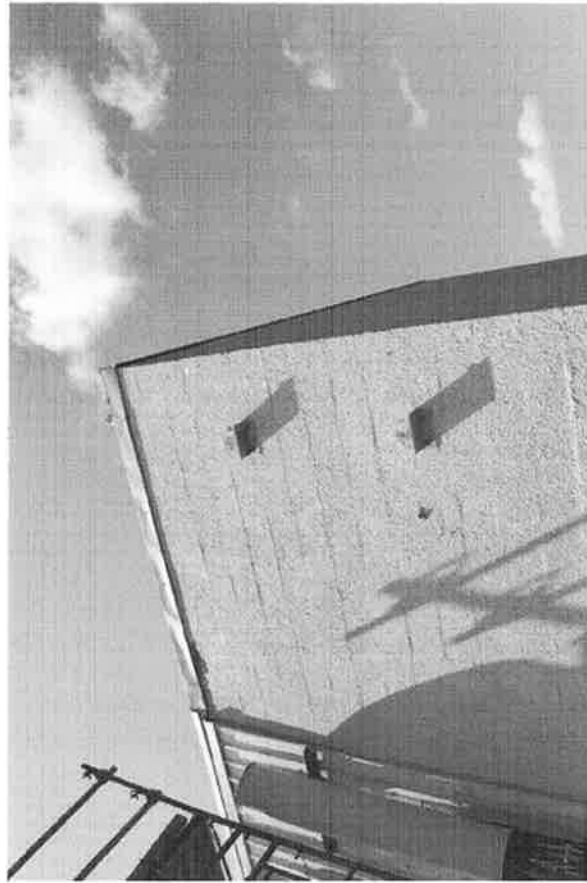
Photograph 46: Rust on metal paneling at elevator shaft (typical)

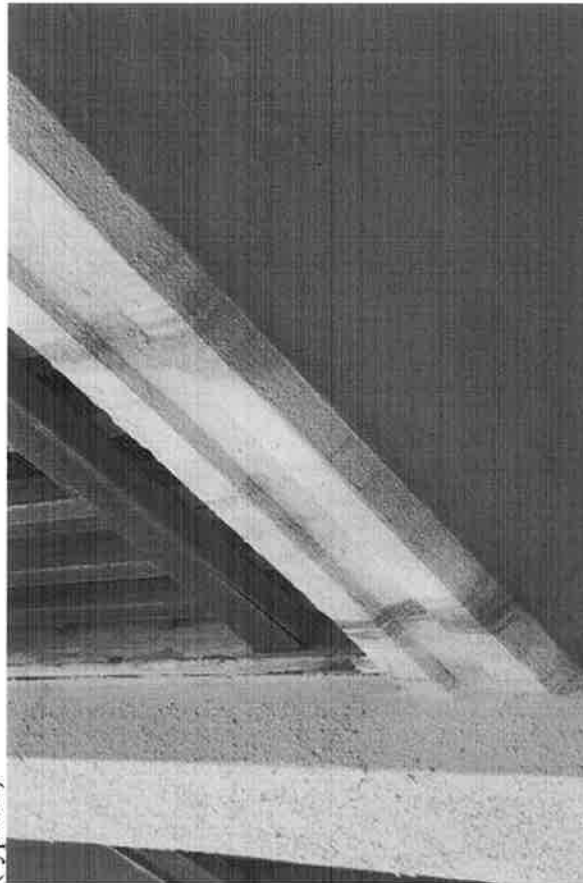
Photograph 48: Isolated corrosion in hollow core concrete panel (typical)

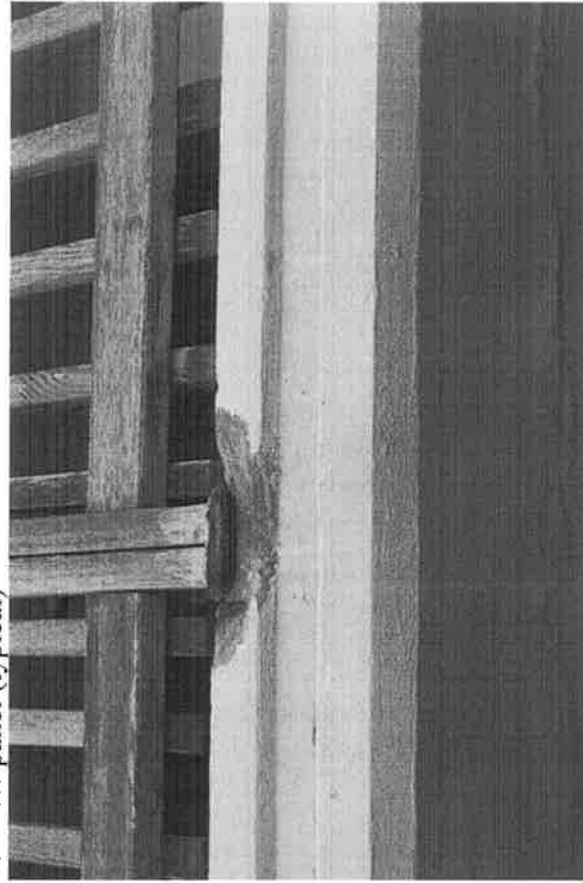
Photograph 50: Isolated spalling at railing connection to hollow core concrete panel (typical)

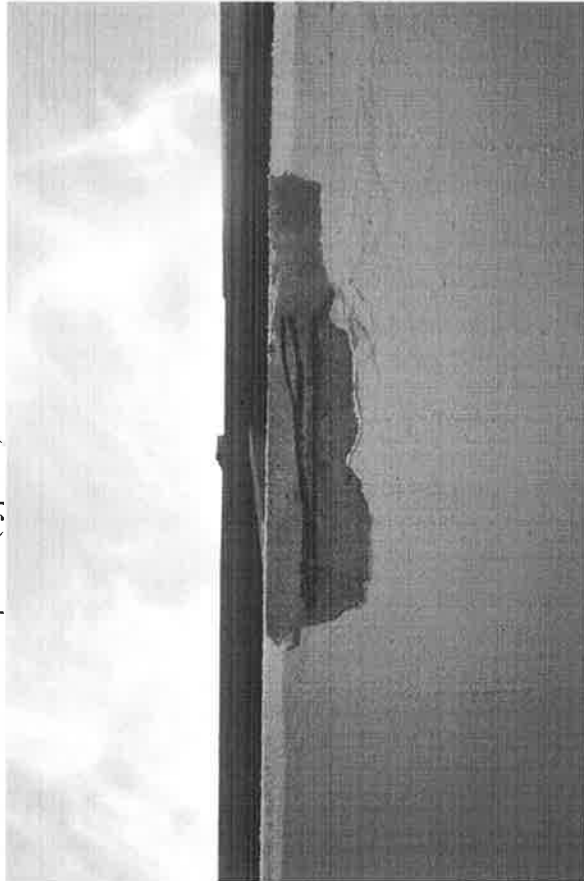
Photograph 52: Rust accumulation on exposed pre-stress cable in hollow core concrete panel (typical)

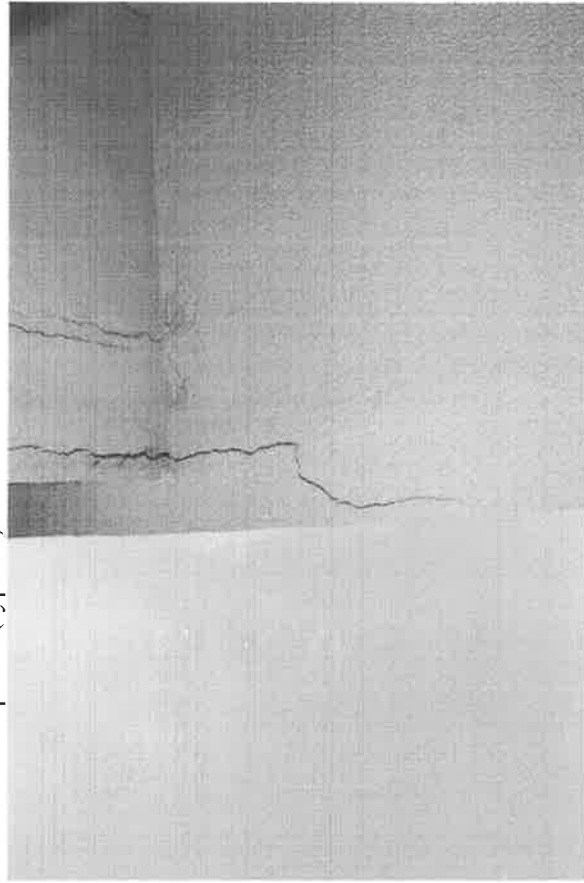
It was also readily apparent that the Mustang Tower condominium building had experienced a history of corrosion in both the concrete elements of the super structure as well as in the metal paneling on the elevator shaft (ref. photographs 44-46). Inspection of the balcony areas of selected condominium units revealed isolated spalls in the pre-cast hollow core concrete panels used to construct the building (ref. photographs 48-55 and 60-63). This includes isolated spalls at the connections between the railing and the hollow core panels (ref. photographs 49-51). Isolated areas showed severe corrosion in the exposed steel reinforcing cables in the hollow core concrete panels (ref. photographs 52-53 and 62-63). Inspection of the pre-cast hollow core concrete panels also revealed evidence of prior repair (ref. photographs 54 and 56-59). This is typical for a 30-40 year old, steel reinforced concrete structure, located in the harsh environmental conditions along the Gulf of Mexico. Other areas of the hollow core concrete panels exhibited evidence of ongoing spalling/cracking in the areas of the pre-stress cables (ref. photographs 54, 55, and 60-63).

Photograph 54: Concrete spalling in areas of prior repair to hollow core concrete panel (typical)

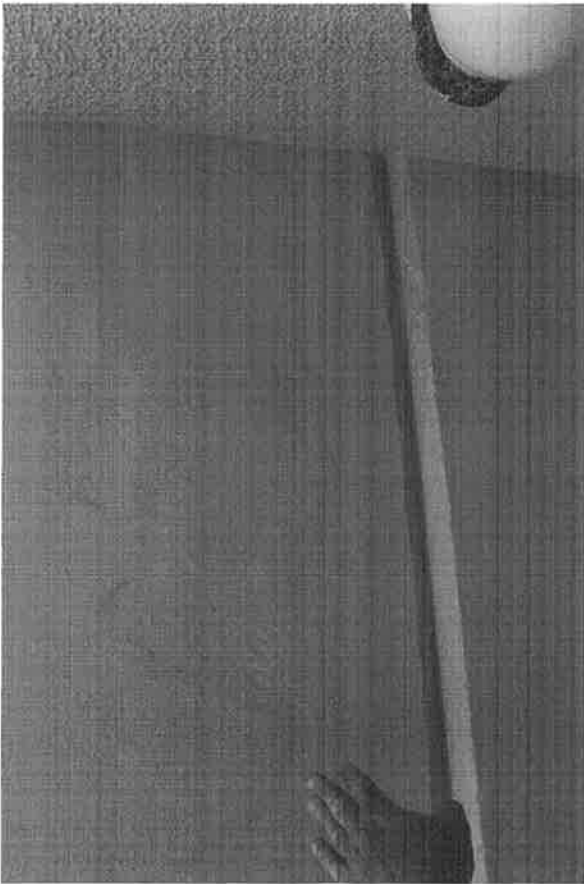
Photograph 55: Isolated cracking along direction of pre-stress cable in hollow core concrete panel (typical)

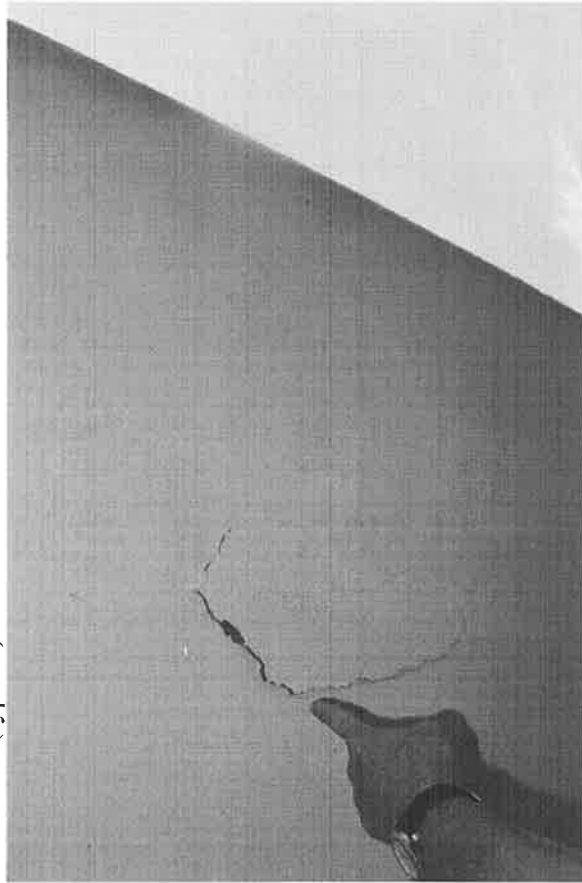
Photograph 60: Isolated spall on surface of hollow core concrete panel at unit 501 (typical)

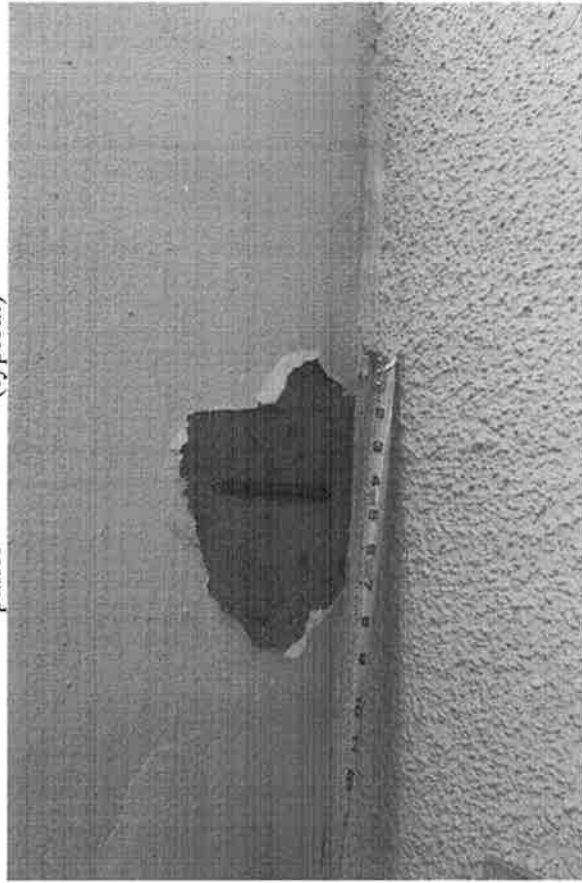
Photograph 62: Spalled concrete and corroded pre-stress cable in hollow core concrete panel at unit 401 (typical)

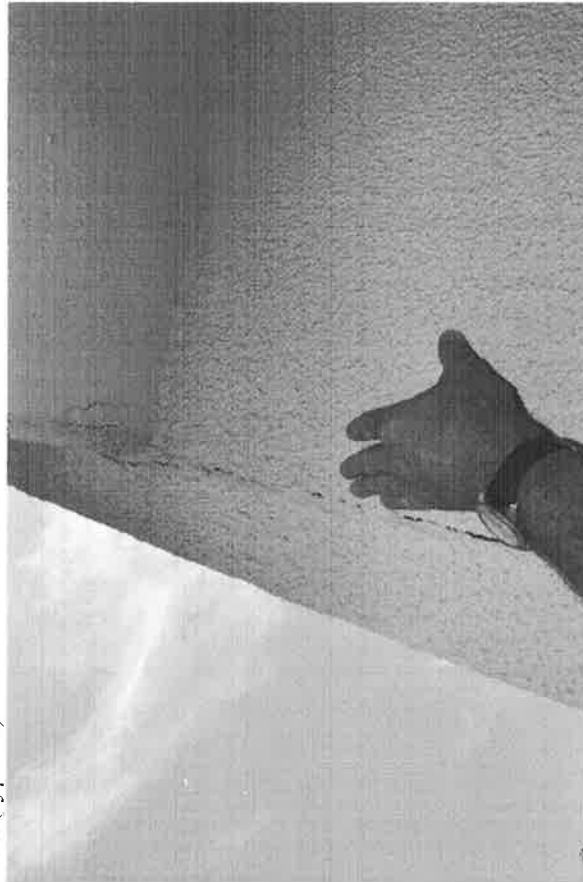
Inspection of this condominium building also revealed evidence of a long history of cracking and repair in the reinforced CMU walls supporting the hollow core concrete panels (ref. photographs 64-79). This cracking was most severe on the east side of the building, with direct exposure to the Gulf of Mexico. Many of the repaired cracks in the CMU walls exhibited evidence of additional distress (ref. photographs 64-67, 70, and 74). Other areas of distress in the building also exhibited evidence of prior repair (ref. photographs 66, 69, 71, 73, and 75). The ongoing cracking and related distress in the CMU walls is the result of long term exposure to the harsh coastal environment. The ongoing distress in the CMU walls is not related to Hurricane Harvey.

Photograph 64: Isolated crack along previously repaired area of CMU wall (typical)

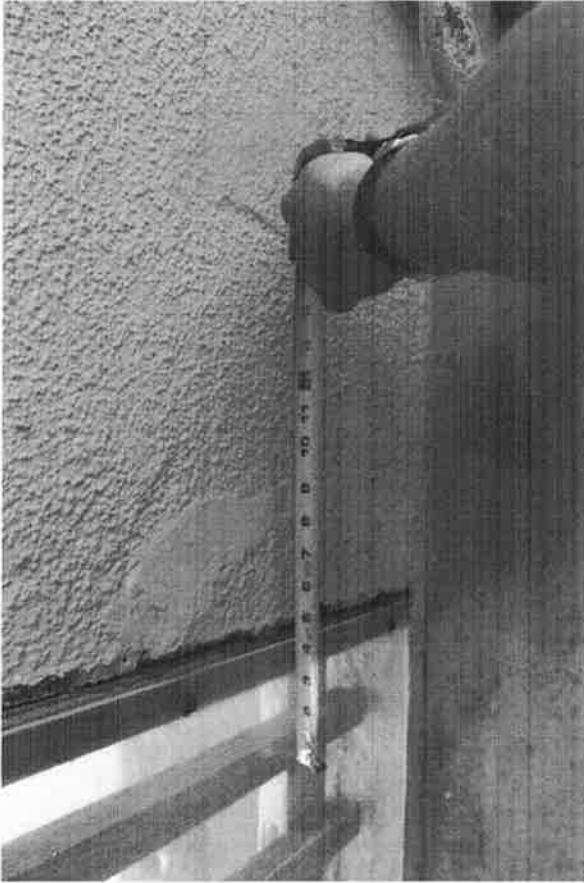
Photograph 67: Isolated hairline crack in CMU wall (typical)

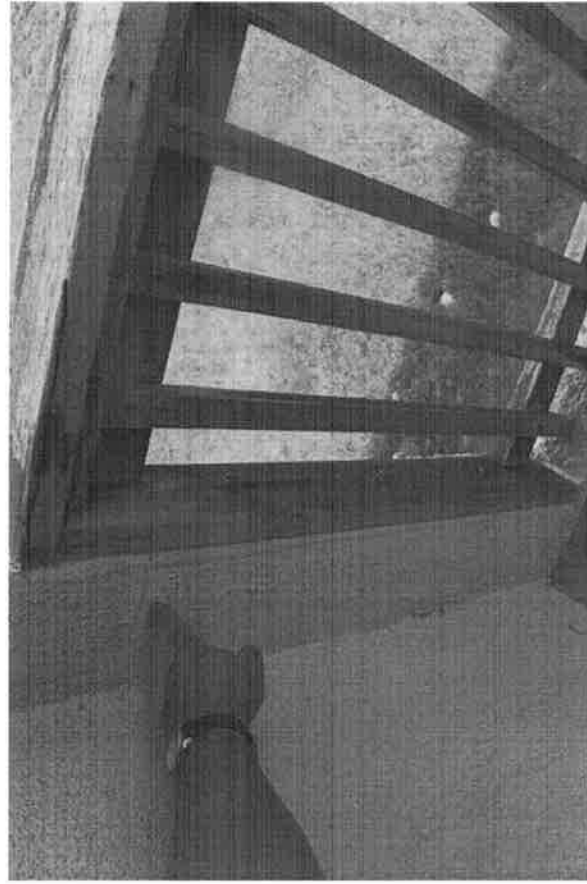
Photograph 78: Spalling in CMU wall at unit 401 (typical)
